SERVICE INFORMATION

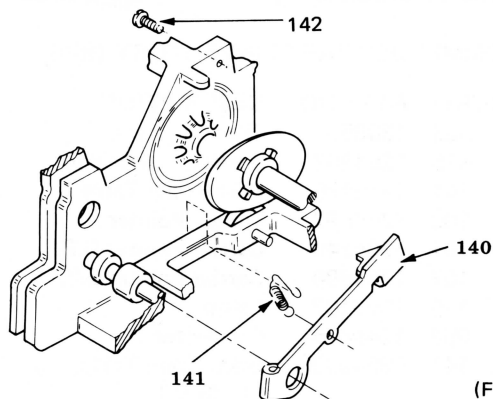
(Figure 1)

The cycle clutch check pawl, stud and spring has been designed to improve cycle shaft cam stop location (Figure 1).

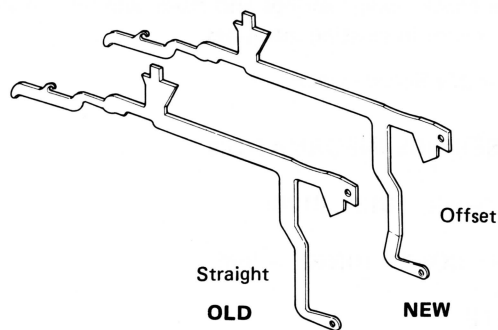
(Figure 4)

The tab keylever (18-28, 19-43) has been redesigned (Figure 4), to ensure there is no interference between the check pawl (23-140) and tab keylever. The new redesigned tab keylever will work on all level machines. The old level keylever will be obsolete. Scrap all old level keylevers and reorder new style.

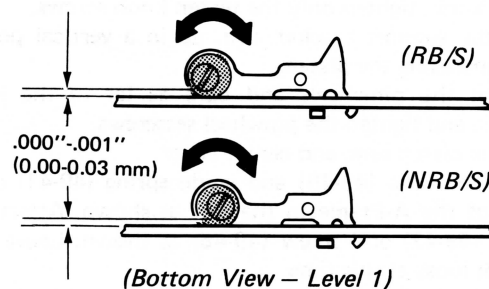
Pawl Mounting Stud (Final)
(06-26)

Frame 119 of APM 241-5939-3 is incorrect. On NRB/S
machines, the eccentric screwhead should be to the left and on
RB/S machines, the eccentric screwhead should be to the right.
This correction is shown in Figure 1. Mark this change in
your APM.

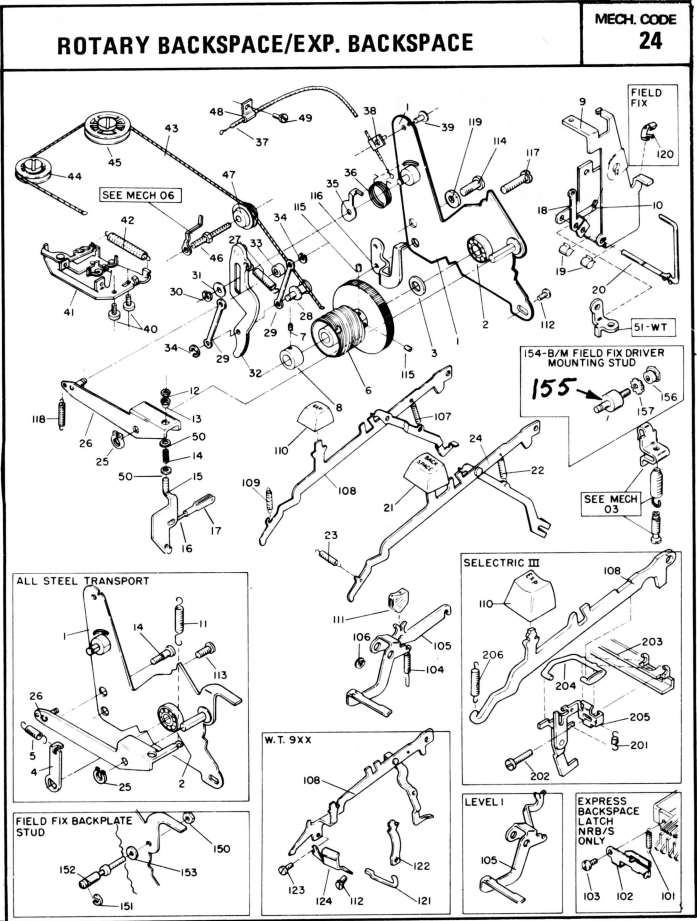
PURPOSE:
The reference number for the field fix backspace driver mounting stud is incorrect. It should be part reference 24-155. Mark this correction in your APM.

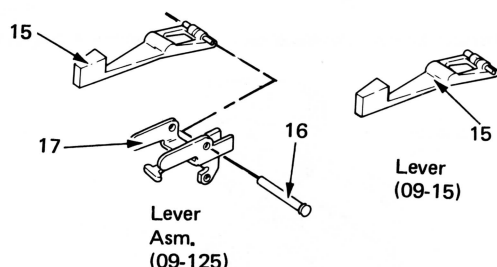
The margin set levers (09-15) and set lever assemblies (09-125) have been changed to metal to reduce breakage. The lever and asm. are compatible with current level margin stops (09-18, 35). Machines without current level stops below 7X1 - 4218186, 7X3 - 4859623, 7X5 - 4510354 must have the margin lever asm. (09-125) replaced.

NOTE: When replacing a plastic set lever or asm. with the metal lever, both levers should be changed to the metal lever.

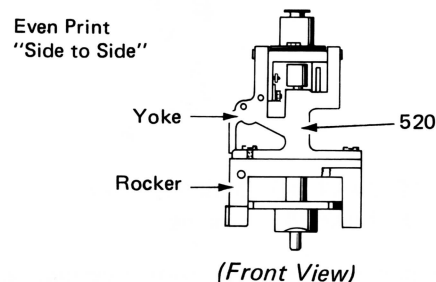
Figure 1

"Selectric" and "Selectric" II prior to eccentric overthrow index pawl stop: replace the yoke.

"Selectric" and "Selectric" II with eccentric overthrow: Install B/M (22-314). This B/M includes new LH and RH platen supports (22-280, 291) which have been modified to allow the platen to be adjusted lower. The parts are color coded a gold tone for identification. Individual P/Ns for the LH and RH supports will not be made available. If replacement of the supports does not solve the problem, the yoke must be replaced.

"Selectric" III: Replace the yoke (02-520) (platen supports are not available as separate parts on "Selectric" IIIs).

NOTE: If yoke replacement is required, check print adjustments, fine alignment, and character selection adjustments, with emphasis on even side-to-side printing, skirt clearance, and homing. Also make sure that the carrier does not contact the feed rolls during carrier movement.

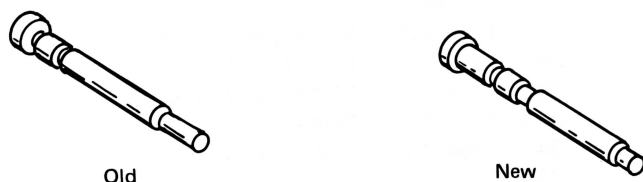
Figure 1

Selective ribbon machines are now manufactured with the same ribbon feed cam follower, FTB (15-010) as is used in Electronic Typewriter. A new pin (15-019) is required to mount the follower. (Figure 1 illustrates the old and new pin).

The former level follower is no longer available. If replacement is required, order both the new follower and pin. Old level pins remain available.

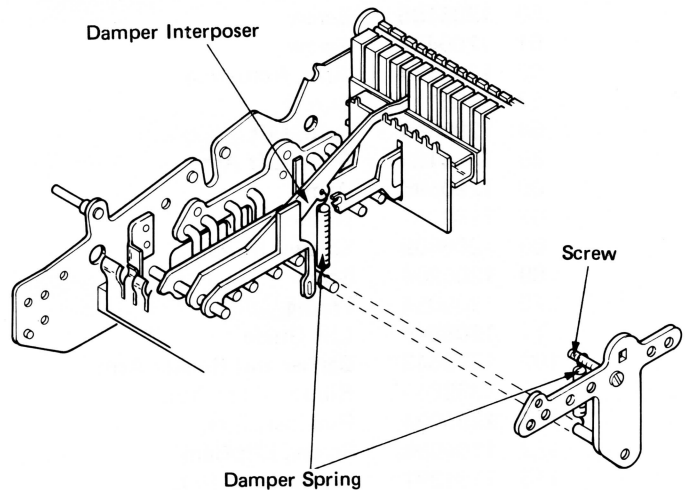
Figure 1

The cycle clutch bail leaf spring (21-240) has been replaced with coil springs on both sides of the key board. This change was made in order to maintain a more reliable adjustment of the cycle clutch latch pawl to keeper on the assembly lines. It will also allow the touch to be distributed more evenly across the keyboard.

The LH spring (21-210) is connected to an interposer (21-113) that has been added to the LH side of the keyboard (Figure 1). The right and left damper springs can be installed in keyboards in the field by ordering the interposer, screw, and springs. On the RH side replace the center screw in the plate with the longer screw that was ordered and attach the spring. The center leaf spring will remain available.

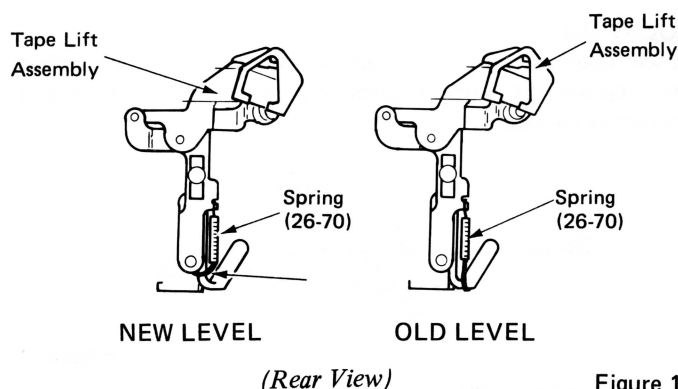
Figure 1

The correction lift guide restore spring (26-70) has been redesigned to prevent the bottom loop from contacting the D.I. cable or dust shield. The new shorter spring hooks in a corner of the lift bracket as shown in Figure 1.

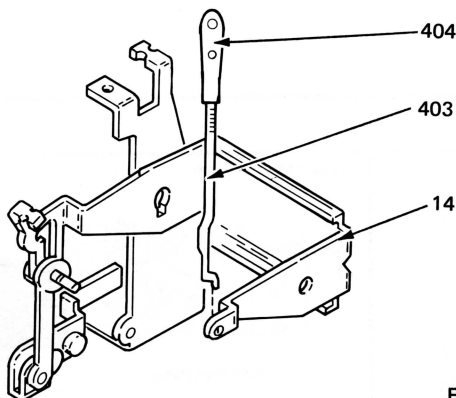
Figure 1

The lower end of the index link (20-403) has been changed to improve reliability. The new link utilizes an offset in place of the permanently mounted clevis. The new link may be installed by first removing the trigger restore spring (07-41). Install the offset end of the link as shown in figure 1. Then attach the clevis to the link from the top of the machine.

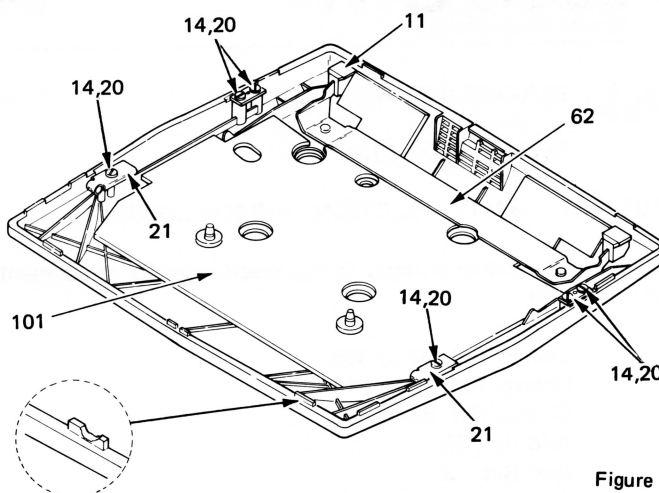
Figure 1

When converting from a metal bottom cover to a plastic bottom cover, check for a possible interference between the bottom cover and the center cover. A limited number of center covers (30-156) were manufactured with a rib that may contact the front guide lug on the plastic bottom cover (Fig 1). This interference can be eliminated by filing enough material from the front bottom cover plastic guide lugs to allow proper assembly.

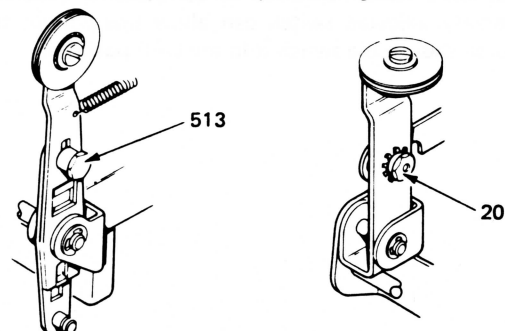
Figure 1.

Manufacturing has redesigned the rotate arm screw (23-513) and the tilt arm nut (23-20) for the purpose of using an automated selection adjustment system (Fig 1).

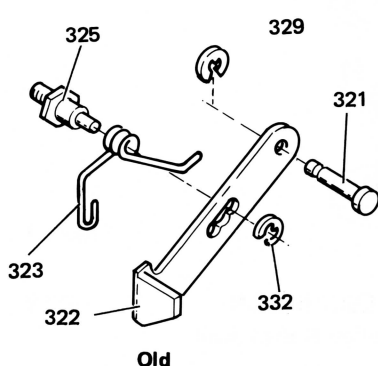
Figure 1

The selector cam lever (20-322) and stud (20-321) are now one piece. Additional stability is provided by the selector cam lever (20-322) interlocking with the adjustable stud (20-325). The tension spring (20-323) was modified to accommodate the adjustable stud (20-325). "C" clips (20-329) and (20-332) are not required with new level parts.

PARTS INFORMATION: The previous level parts (321, 322, 323, 325) are no longer available. New level parts are not compatible with previous level; if replacing an old level part, new level (322, 323, 325) must be installed.

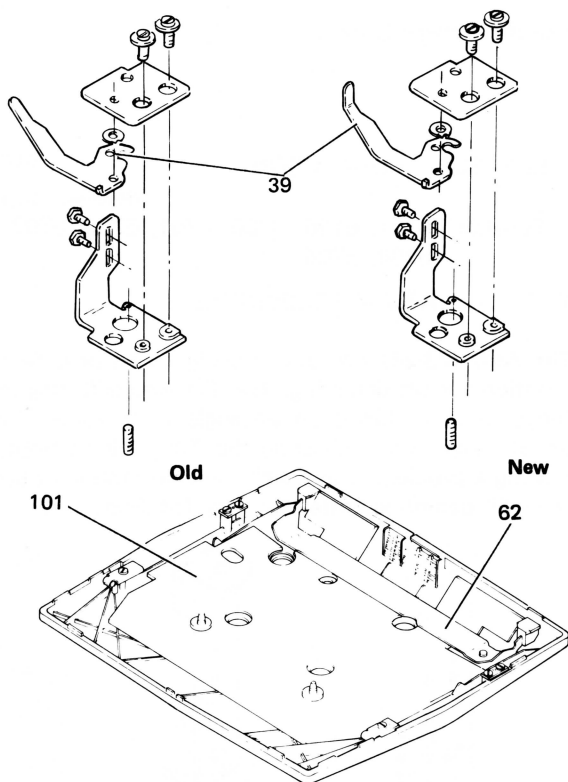
The IBM Personal Typewriter is now being manufactured with a plastic bottom cover. The new plastic bottom cover is interchangeable with the previous level metal bottom cover.

A new level Latch Lever (05-39) must be installed when converting from metal to plastic bottom cover (8 x 1).

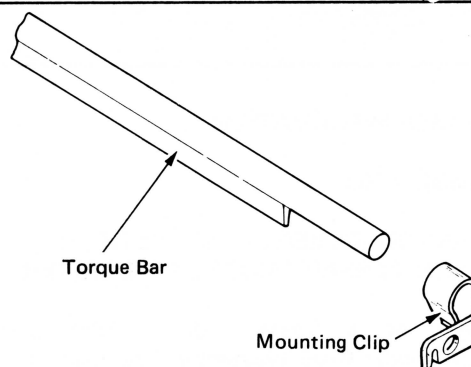
Figure 1

The Pre-Floating torque bar P/N 1206100 has been replaced by a B/M. The new B/M includes a Mag Card torque bar and two clips. When installing the B/M, remove the Mag Card torque bar spring anchor and install the new link mounting clip (Fig 1). A clip is included which should be used to control torque bar end play.

NOTE: After removing the Mag Card torque bar spring anchor, use a file to remove sharp edges.

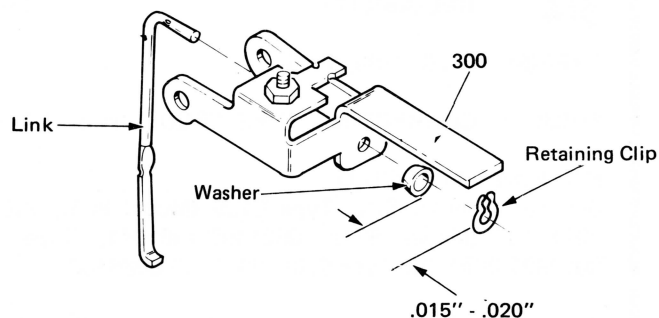
Figure 1

The Spacebar Latch Assembly (17-300) is now assembled with a replaceable latch link for use in the Personal typewriter. Should replacement of the latch link become necessary, a B/M is available which contains the link, a washer and a retaining clip.

NOTE: Maintain a .015" - .20" clearance between the washer and retaining clip.

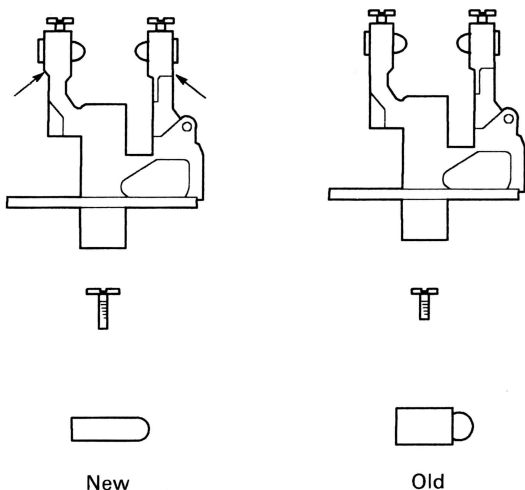
Figure 1

Selectric® carrier yokes (02-520) have been improved by increasing the thickness of the uprights and by decreasing the diameter of the tilt ring pin hole. These yokes require smaller diameter tilt ring pins (02-301) and longer tilt ring pin screws (02-302). See Figure 1.
